**EVALUATION OF TREES AT THE
SOUTHBAY CHRISTIAN CENTER
521 E. WEDDELL DRIVE
SUNNYVALE**

**Michael L. Bench
Consulting Arborist
August 4th, 2005**

Job # 08-05-157 Site I

EVALUATION OF TREES LOCATED AT SOUTHBAY CHRISTIAN CENTER, 521 E. WEDDELL DRIVE,
SUNNYVALE

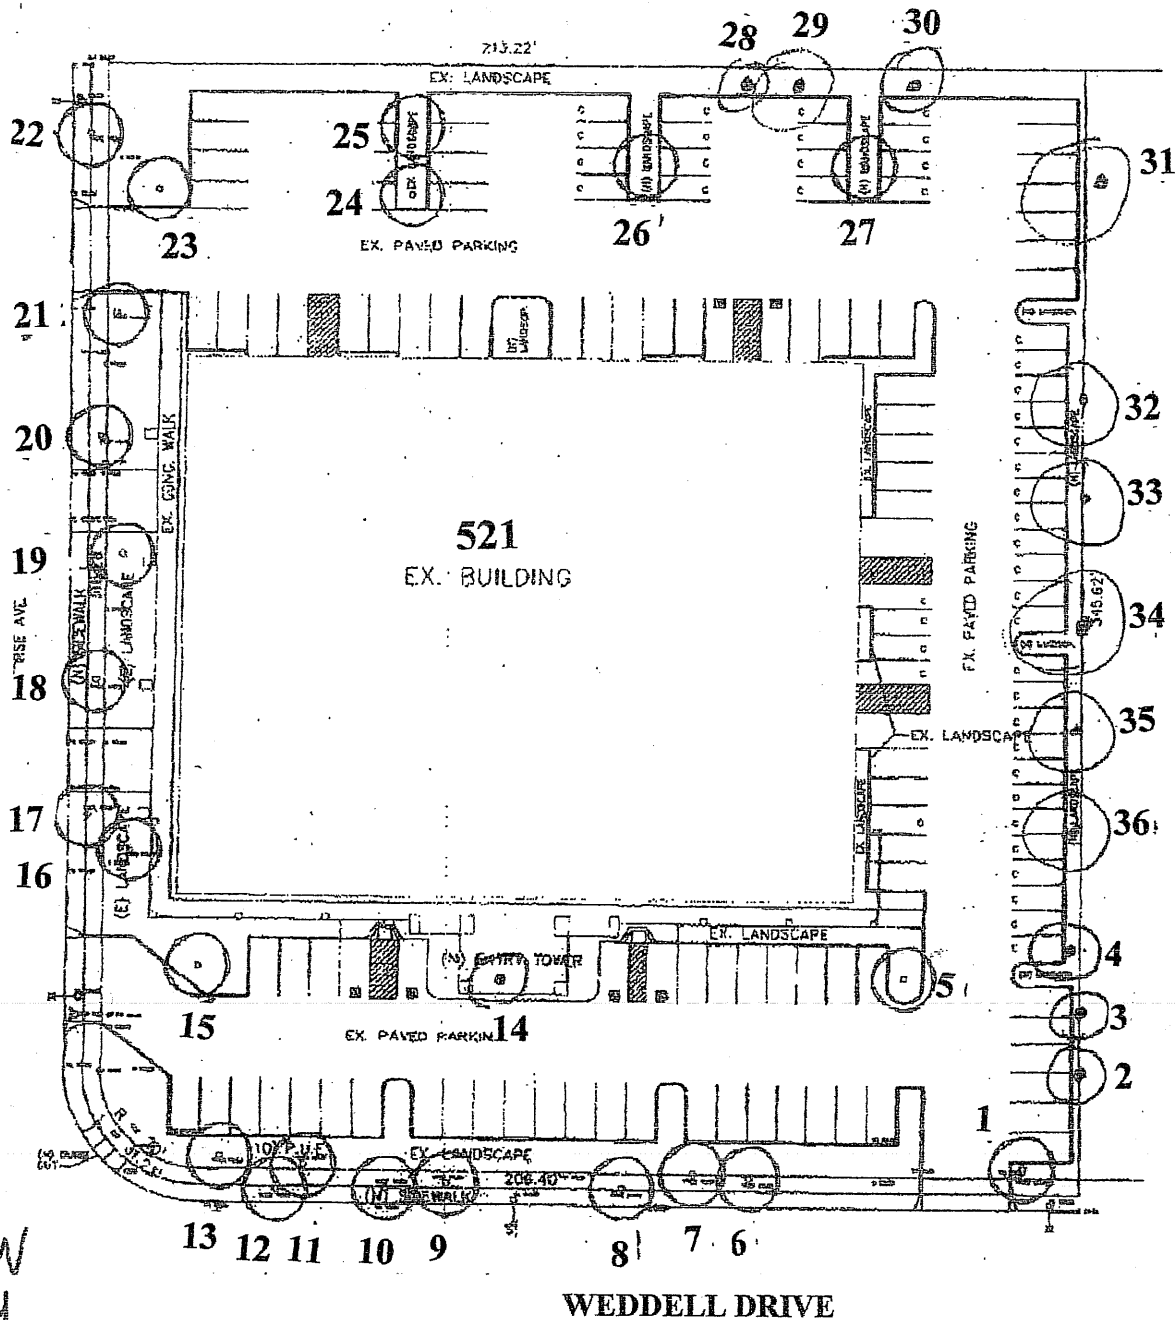
Tree numbers correspond to evaluation charts.
 All dimensions and tree locations are
 approximate.
